## SAFETY ALERT BULLETIN

Accident Reduction  
Program

April 2004

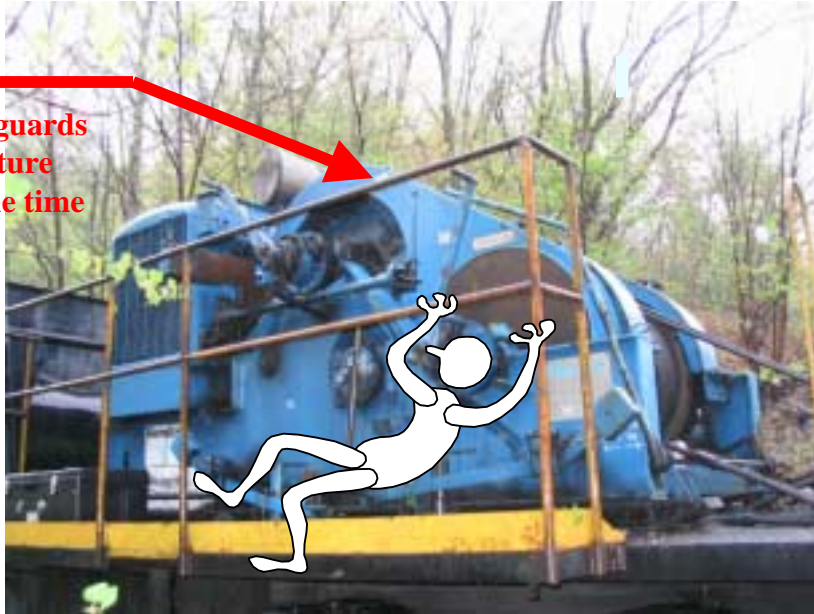
All the handrail guards shown in this picture were absent at the time of the accident.

On Sunday, April 25<sup>th</sup> 2004, at approximately 3:30 p.m. an independent contractor employee received serious injuries when he fell approximately 55 inches from an elevated platform to the ground below through an opening created by the absence of all the removable handrail guards. The contractor employee was operating a truck mounted hoist wench at the surface area of a large underground coal mine located in Buchanan County, Va.

The accident occurred when the mechanical drive line-universal joint came apart while the employee was attempting to engage the wench to reel up the hoist cable slack. The employee lost his balance and fell from the elevated platform to the ground below through the opening created by the failure to install the removable handrail guards prior to operating the hoist wench. His injuries included multiple fractures of the left wrist and a laceration on his forehead above the right eye.

- If handrail guards are removable, all employees/contractors should be instructed these handrail guards **must** be in place before performing any work in the affected area.
- Ensure all handrail guards are properly installed and properly maintained when working on any elevated walkway/platform.
- Conduct required pre-operational checks on all equipment before operating.
- Ensure all contract employees receive proper training before entering mine property and prior to operating any equipment.
- Maintain all equipment in safe operating condition.
- Conduct required onshift examinations of all mobile equipment.
